# **Short-Term Performance of a Newly Developed Connection for Use in Precast Double Tee Systems**

Submitted to the Faculty of Graduate Studies and Research  
through The Department of Civil and Environmental Engineering  
in Partial Fulfillment of the Requirements for  
the Degree of Doctor of Philosophy at the  
University of Windsor

The focus of this work was to investigate the effectiveness of using advanced composite materials to enhance double tee to double tee connections in regions of significant seismic and lateral load. This work stems partly from the unfortunate losses experienced during the 1994 Northridge California earthquake. Moreover, this work was also developed from discussions with a local precasting company, which is concerned about premature failure of the connection due to stress concentrations. The author contends that the current connection method, intermittent welded plates, does result in stress concentrations, which can effect the system's overall performance.

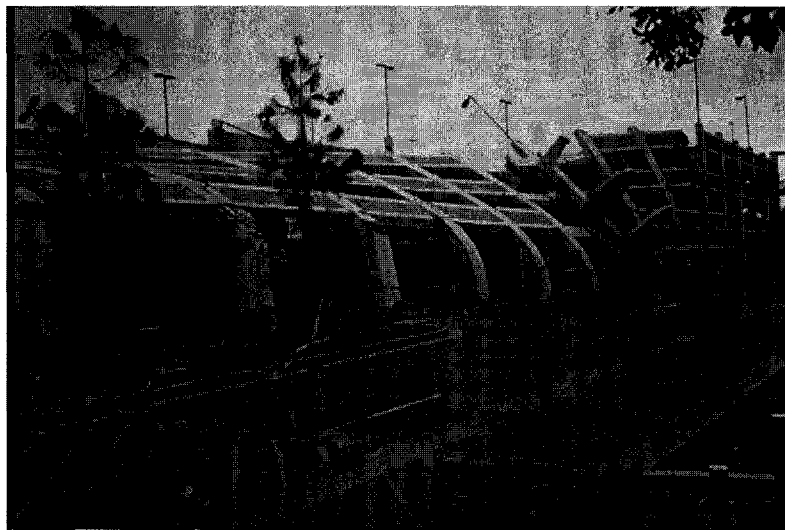
Figure 1.3: Photograph of Collapsed Precast Structure in Northridge 1994 (NGDC 2004)

Figure 1.3 is a photograph of one of the failed precast parking structures. From a subsequent series of investigations into the failed precast structures, it was found that the connection between the members, forming the diaphragm, was limited to a reinforced concrete topping. While no mechanical connections were provided, it is anticipated that had these connections been present, failures would have still occurred, albeit less severe.

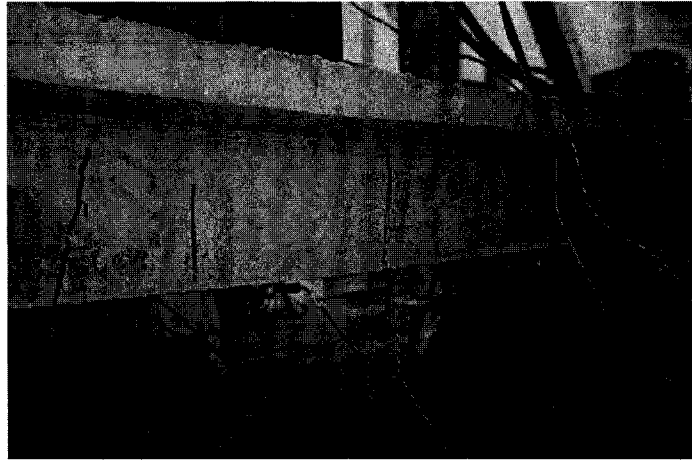
Figure 6.2: Crack Spacing for Individual Double Tee Member  
(in Region of Mid-Span)

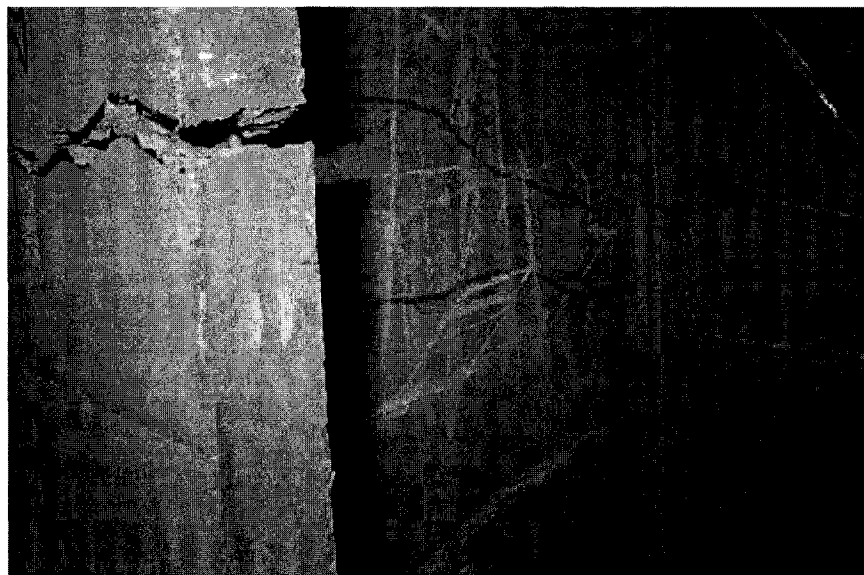
Figure 6.10: Crack at Mid-Span at the Ultimate Load

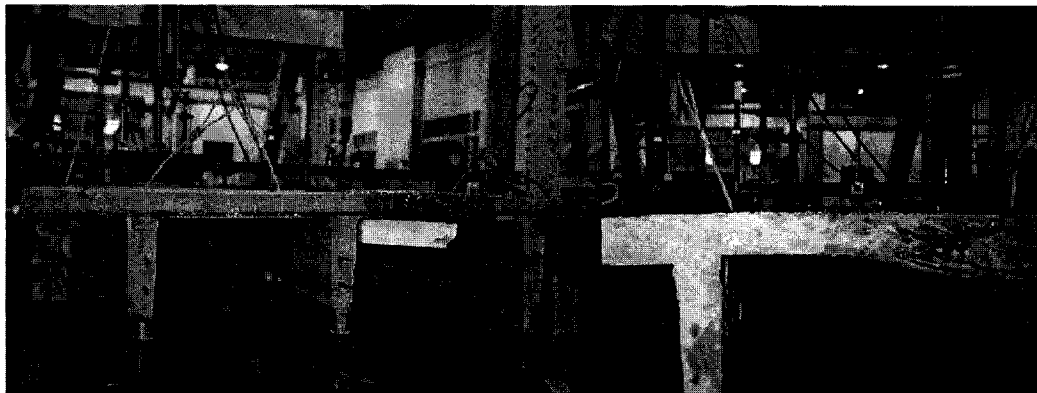
Figure 6.17: Close-up of the Composite System's Joint Under Loading
